Radon in Air Testing Report

2018/2019

Red Deer Catholic Regional Schools

Red Deer Catholic Regional Schools 2018/2019

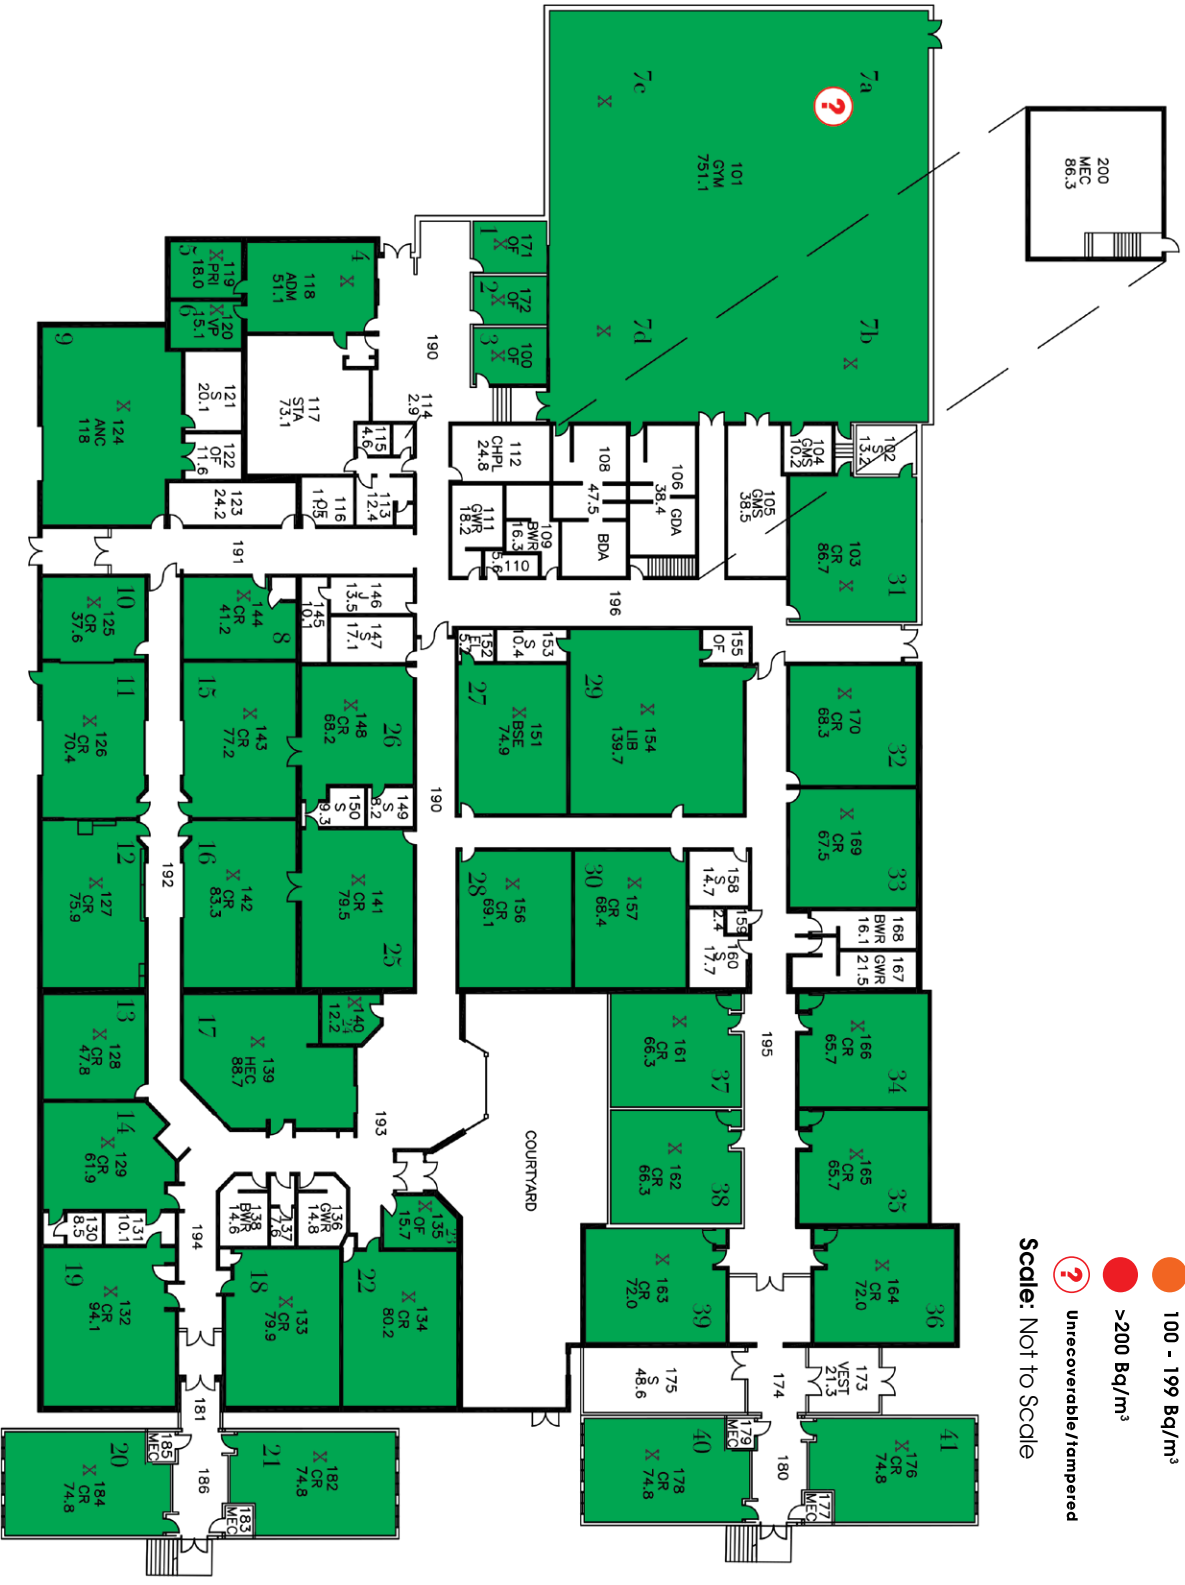
Table 3.16 St. Matthew

LEGEND

- Rooms not measured
- <100 Bq/m³
- 100 - 199 Bq/m³
- >200 Bq/m³
- ⊗ Unrecoverable / tampered

Long term radon sampling of selected rooms in St. Matthew were well below both Health Canada and World Health Organization action level guidelines.

Sampling completed from December 26 2018 to April 13 2019 and indicate measured levels are below guidelines and no corrective action is necessary at this time.

RadonCare recommends re-sampling if extensive construction or significant HVAC system changes are completed and after a period not exceeding 5 years from the completion of this survey.

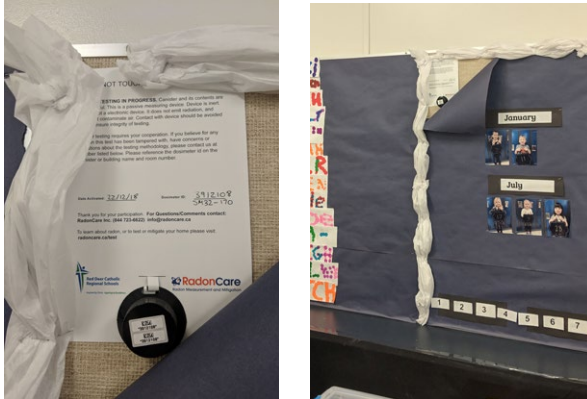
Dosimeter 32-170-3912108 was located on the bulletin board but was partially obscured by background decorative paper.

- 3912108 - **St. Matthew**: Background paper and bulletin paper on board obscuring test
- 3912140 - **Our Lady of the Rosary**: located immediately outside room in hallway on projection cart.
- 3912301 - **Ecole Secondaire Notre Dame**: retrieved from segmented dividing wall buried within alcove.
- 3912303 - **Ecole Secondaire Notre Dame**: retrieved from segmented dividing wall buried within alcove.
- 3912341 - **Ecole Secondaire Notre Dame**: retrieved from outside cage.
- 3912374 - **Holy Family**: dosimeter extremely dusty.
- 3912639 - **St. Thomas Aquinas**: dosimeter covered in fine sawdust.
- 3912268 - **Maryview**: located taped to placard on east end.
- 3912525 - **St. Elizabeth Seton**: Moved to lower position in room.
- 3912580 - **St. Francis of Assisi**: Not attached to fire light cage.
- 3912584 - **Camille J Lerouge**: Covered in paper on billboard.
